# Safety Recall Trucks

Date	Group.	No.	Page
08.12	<b>SC0364</b>		1(7)

Windshield Wiper Motor Pinch Bolt  
CHU, CXU, GU

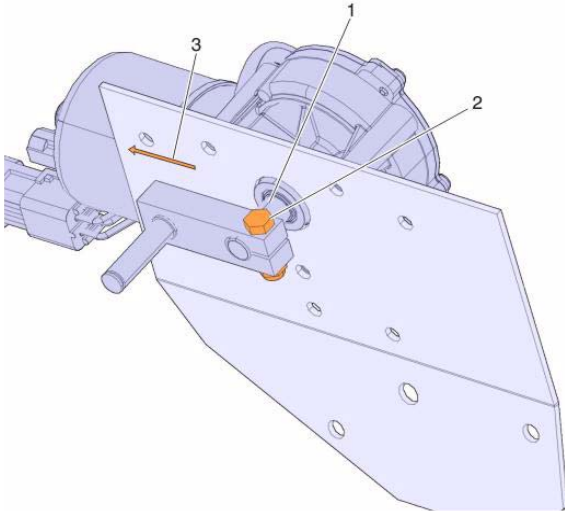
12. Remove the defective pinch bolt from the drive arm.

Note: Once the pinch bolt is removed, the drive arm slides off the splined shaft of the wiper motor. This causes the drive arm to become out of time with the wiper motor. If this occurs, refer to the alignment marks to assist with reassembly

1. Pinch Bolt Alignment Mark  
2. Pinch Bolt  
3. Wiper Arm Bell Crank Alignment.

13. Install the new pinch bolt and nut. Using a calibrated torque wrench, torque to 10 Nm (7.5 ft-lb).

Note: Utilize the previously marked orientation of the drive arm to the wiper motor bracket.
