Date	Group.	No.	Page
The bulletin replaces Safety Recall bulletin SC0375, "Electrical Power Distribution Module (EPDM)" released 05.2014.	05.14	SC0375		1(17)
				Electrical Power Distribution Module (EPDM) CHU, CXU, GU, TD

SAFETY RECALL INFORMATION:

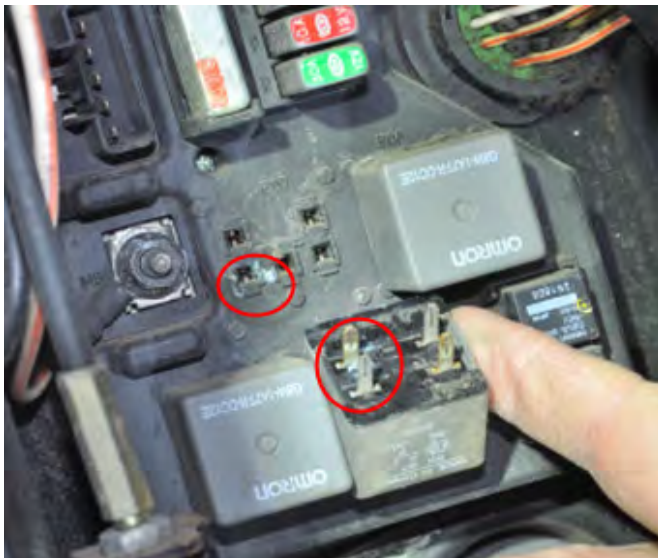
10. Inspect the removed EPDM for signs of water damage. Pull each component from the EPDM and inspect both the component and the EPDM at that location for traces of water. Inspect both sides of the EPDM. If traces of water are found on the EPDM or any component go to step 11a and replace the EPDM and all components. If no signs of water are evident, go to step 11b.

NOTE: This photograph is an example only. Traces of water may be found at various locations on the EPDM, and to varying degrees of contamination.

11. A) If it is determined that a new EPDM is required, using new EPDM 85142790, install 2 x sealed relay 25195026 in positions R01 and R02. Install 3 x sealed relay 25110754 in positions R07, R08, and R09. Populate or remove any other fuses/circuit breakers/relays (using old EPDM as a guide), with new parts.

B) If it is determined that a new EPDM is not required, using the existing EPDM, install 2 x sealed relay 25195026 in positions R01 and R02. Install 3 x sealed relay 25110754 in positions R07, R08, and R09.

NOTE: Any old parts must not be reused if any one component shows sign of water damage. Any part not reused must destroyed.
