SAFETY RECALL

Mack Trucks Inc.
Greensboro, NC USA

Date	Number	Page
7.16	SC0403	1(12)

Interaxle Yoke Retaining Nut

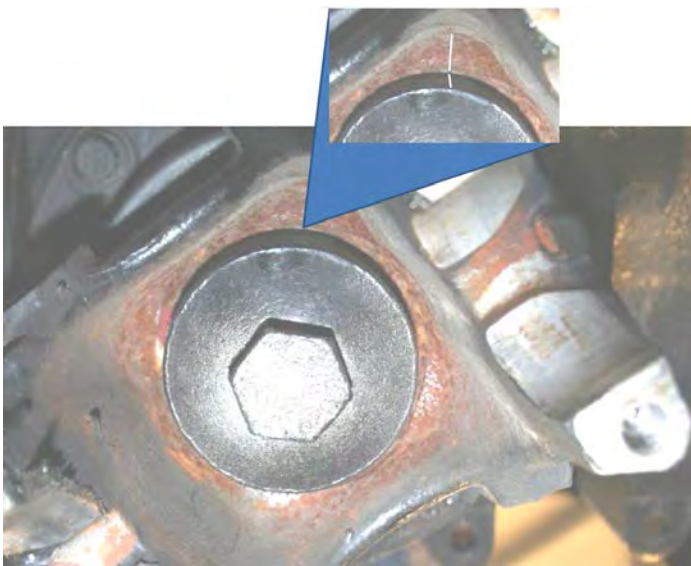
Figure 1

- i. Scribe a line on the nut and a corresponding line on yoke that meet where the nut contacts the yoke (figure 1).

- ii. Check for a breakaway torque by applying 2440 Nm (1800 lb-ft) to the nut in the counter-clockwise direction.
- iii. Verify the nut did not move by observing the alignment of the scribed lines on the nut and yoke
- iv. If the marks are no longer aligned, continue to remove the nut and proceed to step 8.2.
- v. If the alignment remains, nut replacement is not required, proceed to step 22.
