TECHNICAL SERVICE BULLETIN

Issue Date:	7-13-17
Version:	2
Bulletin No:	TSB# T-1001
Operation No:	T1001
Labor Time:	1.0 Hrs.
TSB Classification:	Mandatory TSB <input checked="" type="checkbox"/>

Subject: Engine Alternator Wire Chafing Issue	Company Segment: Power Generation
	Manufacturer: Multiquip
	Model: DCA400SSI
	Engine: Isuzu 6WG1
	Tier Rating: Tier 3

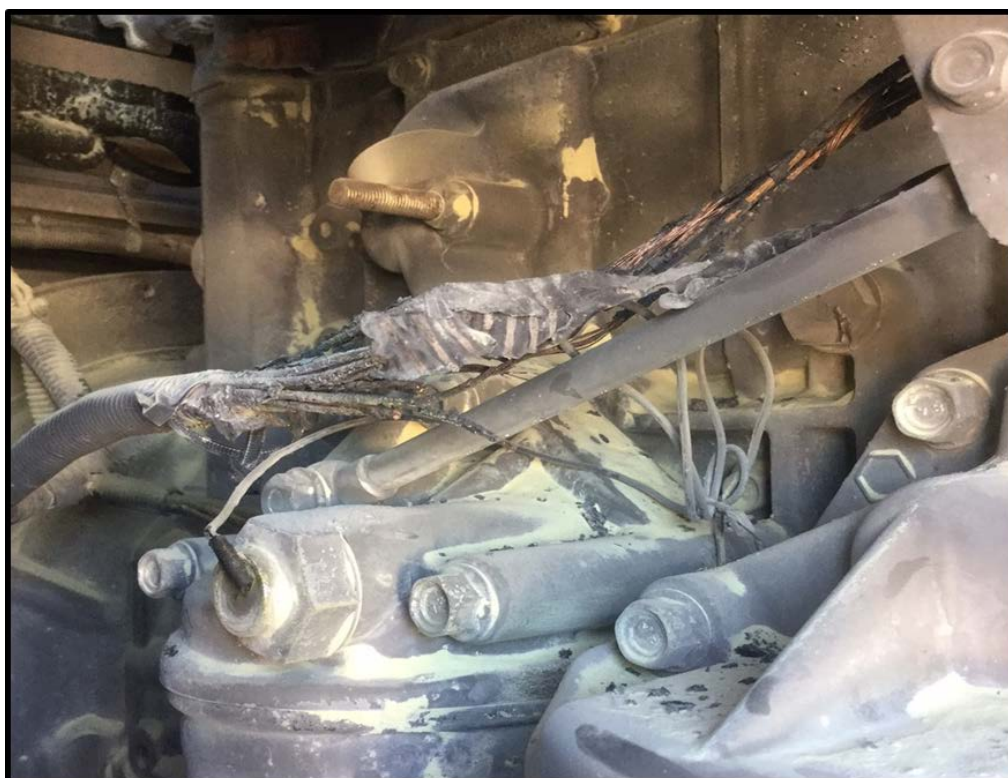
We have experienced an issue on Multiquip DCA400SSIT3 diesel generators that requires your immediate attention! We have documented an incident where the main positive and negative wiring coming off the back of the DC alternator shorted and caught fire due to wire chafing through the insulation against the fuel line bracket above the fuel filters. This potentially damaging hazardous issue is the result of inconsistent routing, dry rotted/missing loom, and improper securement of the harness and has been identified to affect all the Tier3 MQ400's in our rental fleet.
