SVS-08-14 10/21/2014

To: ALL ISUZU POWERTRAIN DISTRIBUTORS AND DEALERS: SERVICE & WARRANTY PERSONNEL

SUBJECT: P0602 DTC FOR TIER 4 FINAL 4LE2 ENGINES AND E-IDSS UPDATES

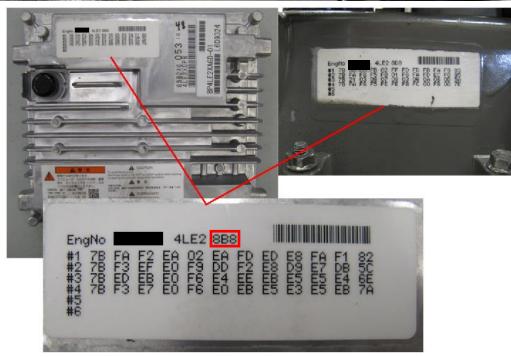
5. Validate the QR Trim code found on the Valve Cover Injector QR code label or, match the QR Trim code stored in the ECU. This information is also found under the ECM Information selection.
