Date	Number	Page
07/23/08	SB213057	1(2)

Camshaft Wear Inspection

MP7, MP8, MP10

SB213057, Camshaft Wear Inspection

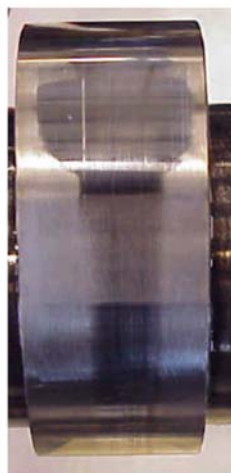
273306a

The following two figures show examples of scoring that will **NOT** affect engine operation. Camshafts with this type of scoring do **NOT** need to be changed.

Figure 1 — Acceptable Unit Injector Lobe Wear, Showing Only a Change in Coloration of the Lobes

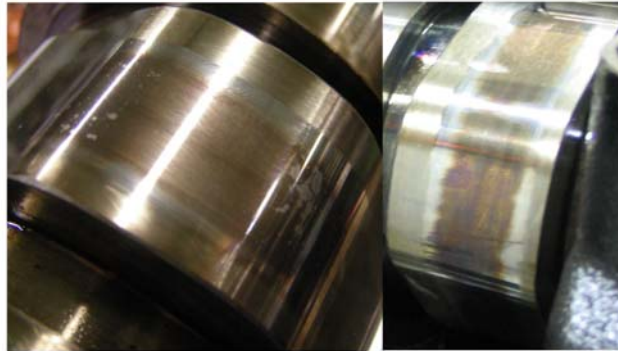
273307a

Figure 2 — Acceptable Inlet, Exhaust and Brake Lobe Wear, Showing Only a Change in Coloration of the Lobes

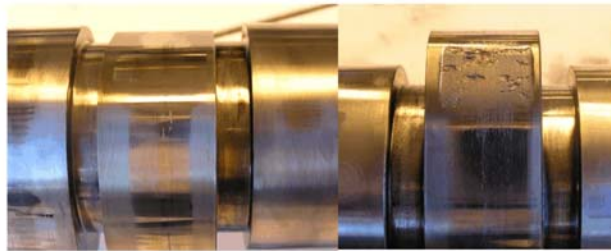
273308a

The following two figures show examples of a camshaft with material damage (several millimeters of damage which can be felt with the fingernail). Camshafts showing this type of damage should **NOT** be reused, and rocker arms at the locations of the damaged cam lobes **MUST** be replaced.

Figure 3 — Unacceptable Unit Injector Lobe Wear

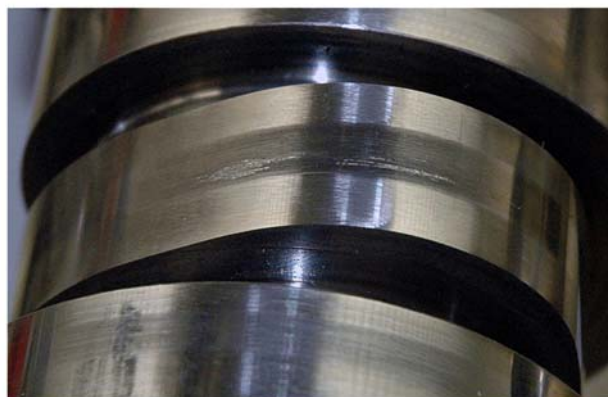
273309a

Figure 4 — Unacceptable Inlet, Exhaust and Brake Lobe Wear
