Bulletin No: T-1000

TECHNICAL SERVICE BULLETIN

Incorrect Configuration of Air Filter Housing

Model : Cummins Power 350

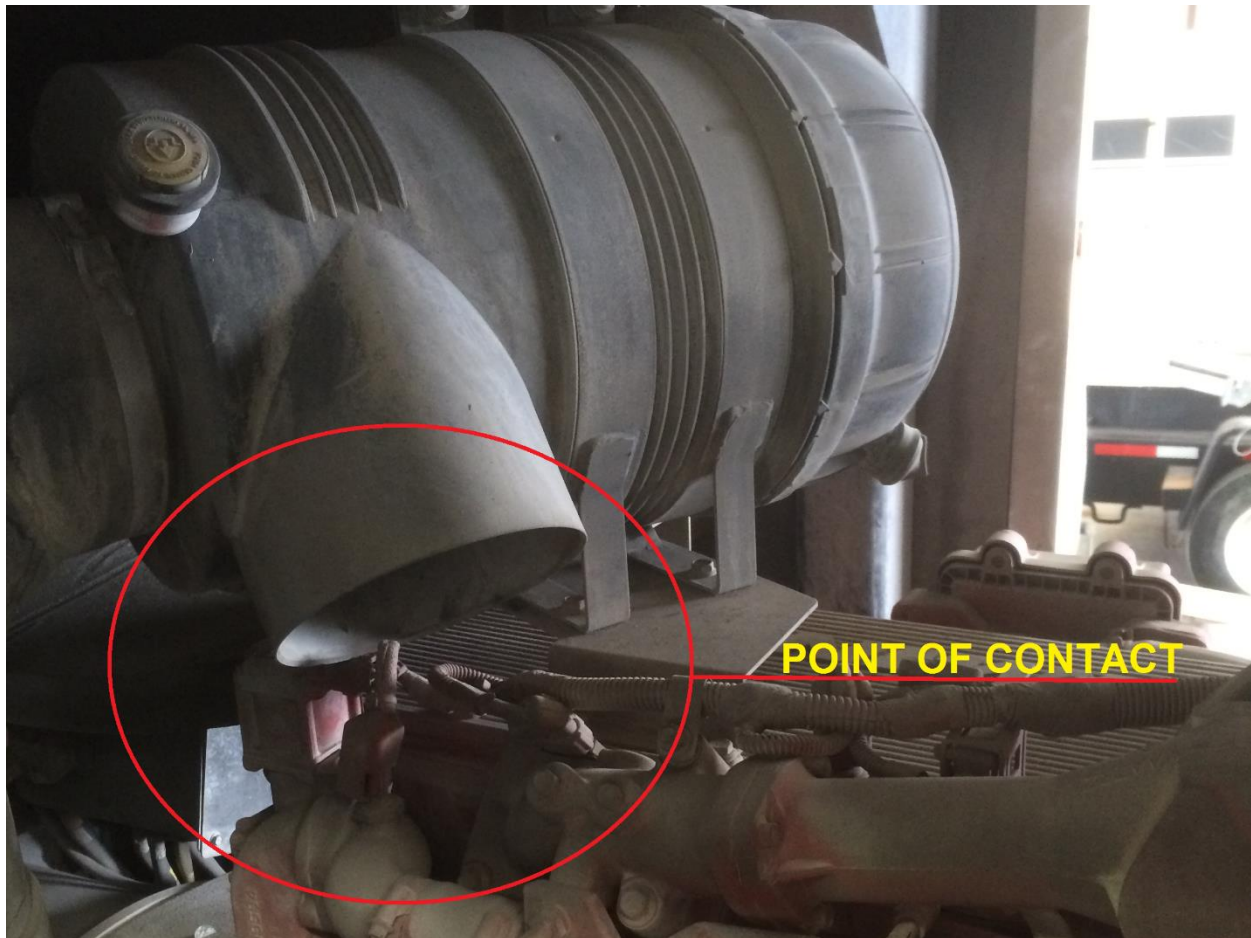
These machines are equipped with a heavy duty 2-stage air cleaner that we are experiencing to be positioned incorrectly and are chafing the exhaust gas recirculation valve motor wiring harness & or connector. Please refer to the illustration below.

Step 1. Loosen the three fastener bolts in the illustration below and reposition the air cleaner to a position where contact with the exhaust gas recirculation valve motor wiring harness & or connector is no longer possible.
