Bulletin No: T-1022

TECHNICAL SERVICE BULLETIN

Main Generator Wires can possibly chafe through the wire insulation & Control box edging, resulting in a potentially hazardous and damaging short to the generator body.

Manufacturer: **Multiquip**

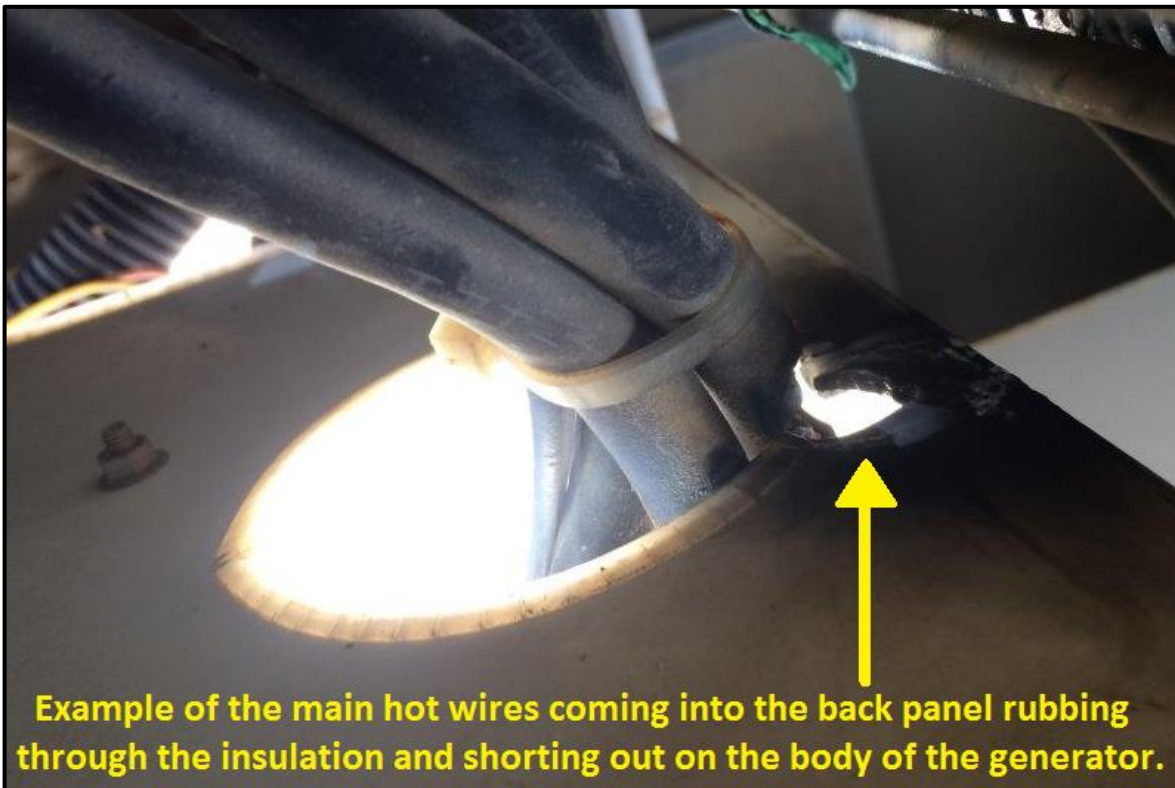
We have experienced an issue on Multiquip generators that requires your immediate attention! We have documented several incidents where the Main Generator Wiring can possibly chafe through the wire insulation & Control Box Edging Part# 0330000210, resulting in a potentially hazardous and damaging short to the generator body. Please thoroughly inspect all of your Multiquip Generators for evidence of this potential issue. So far this issue has been isolated to only the DCA125SSIU & DCA150SSIU models but we suspect it may affect other models also.
