SVS-02-13
5/29/2013

SUBJECT: 6HK1 OIL PAN GASKET PARTS CHANGE AND INSTALLATION PROCEDURE

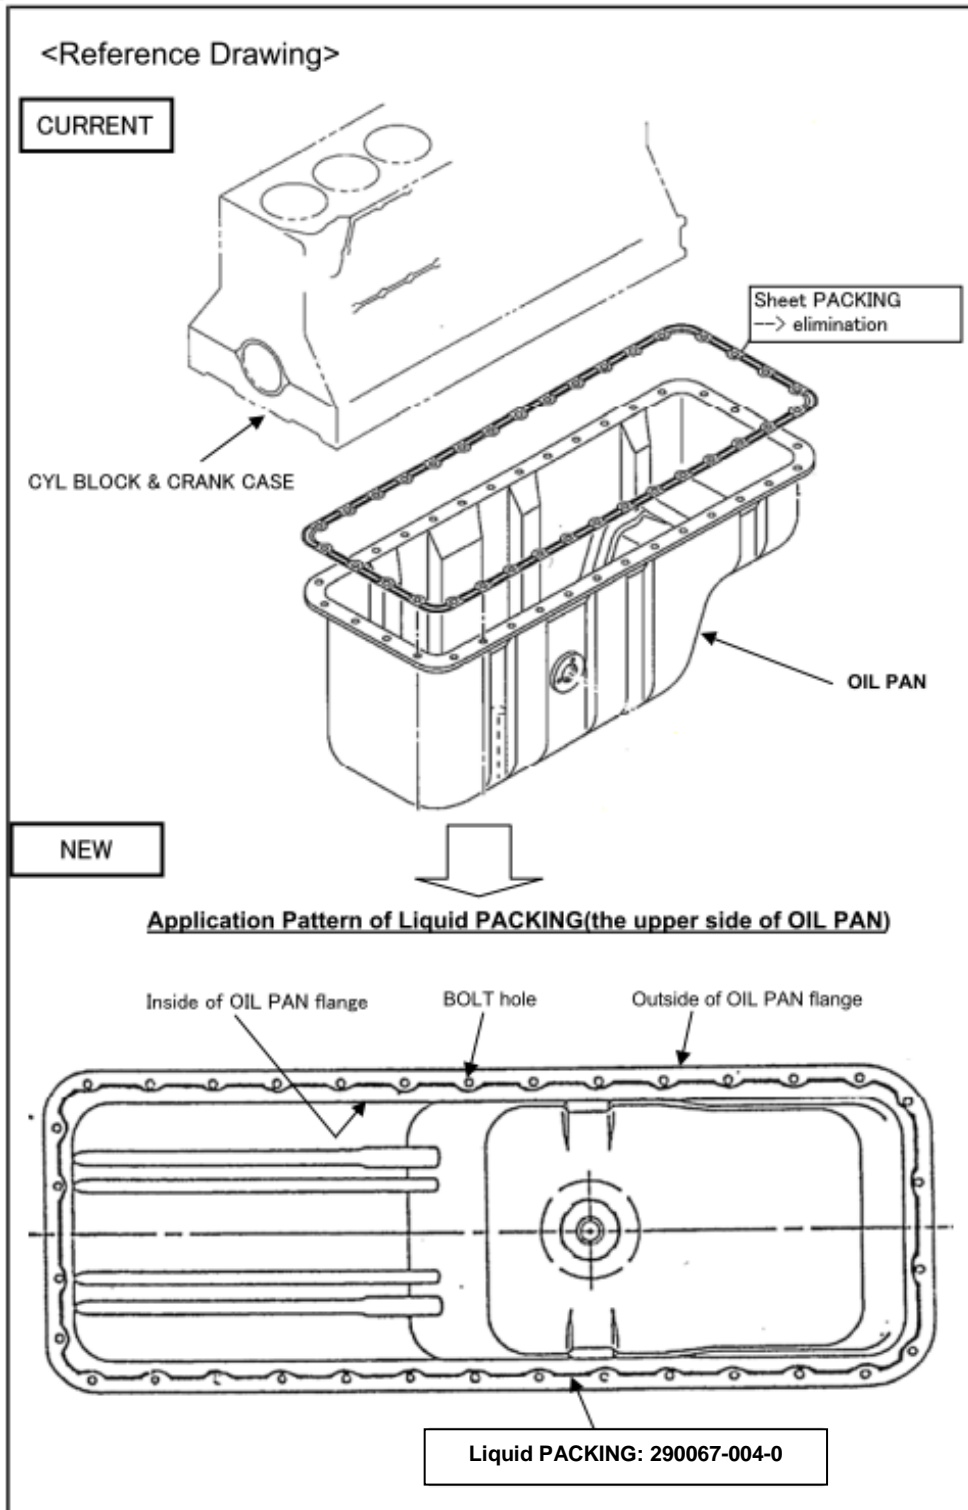
Isuzu Motors America, LLC PowerTrain Division (ISZAPT) has implemented an oil pan gasket change on the 6HK1 engines due to parts commonization. The original oil pan gasket will be replaced with a liquid type gasket. Please refer to the parts interchange chart and pictures below for the needed details. This parts change was implemented in production engines in March 2013.
