To: ALL ISUZU DISTRIBUTORS AND SERVICE DEALERS
Subject: UPDATED FUEL SUPPLY AND RETURN LINE BANJO BOLT FOR ALL 4JJ1 ENGINES

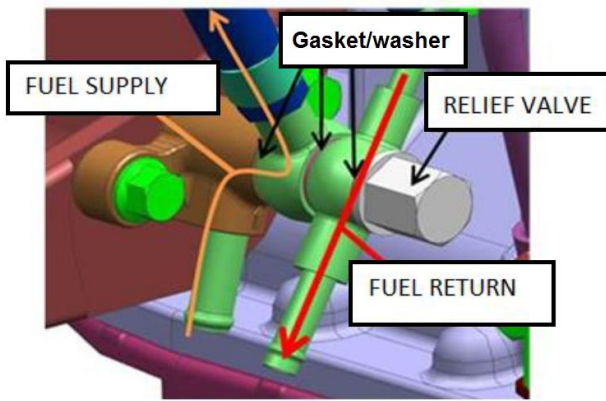
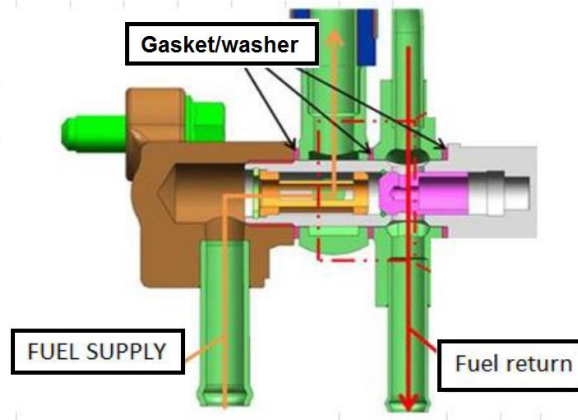
Isuzu Motors America, LLC strives to keep information up to date for our network. There has been a recent update regarding the fuel supply and return line banjo bolt for all 4JJ1 engines. Please see pictures below.

Affected Parts	Current Parts NO.	Q'ty	New Parts NO.	Q'ty
RELIEF VALVE	8980749550	1	8975511850	1
FUEL PIPE PACKING	8982513450	3	8982513450	4

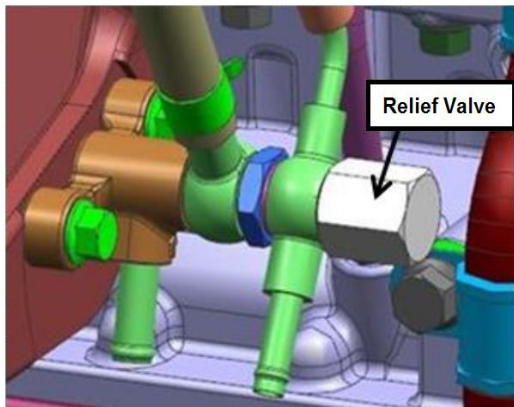
New

The new Banjo Bolt features a Boss in between the supply and return lines, which will require copper washers/gaskets to be installed on both sides of each fuel line. (Please note for purchasing and stocking, copper washers/gaskets needed).
